Geotechnical Investigation SC 1.5 Data Centre Expansion - Stages 2 and 3 Lot 10 South Sea Islander Way, Maroochydore

Prepared for NEXTDC Limited Project No. SG24-1501A

11 June 2024

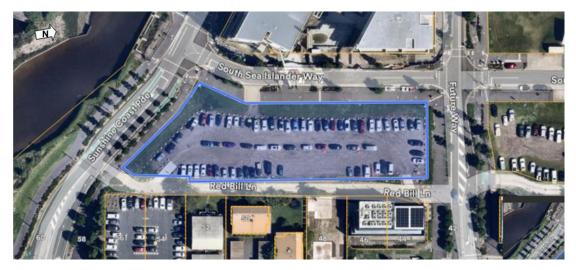
Photograph 1: Aerial view of the site taken on 10 April 2024, with the approximate site boundary outlined in blue (Nearmap Image)

The site is located north of the Maroochydore River and it is bounded by Sunshine Coast Parade to the south and Future Way to the north. A residential development is located to the west, while the existing SC1 facility lies to the northeast, and dwellings to the southeast. At the time of the investigation, the site was being used as a car park, consisting mainly of unsealed parking areas surrounded by garden beds and small to medium size shrubs. The ground surface levels across the site appeared to be relatively level at approximately RL2.8m and formed by past earthworks at the site. A recent aerial view of the site taken on 10 April 2024 (with the approximate extent of the site outlined in blue) is given in Photograph 1 and a general view of the site taken at the time of the investigation is presented in Photograph 2.

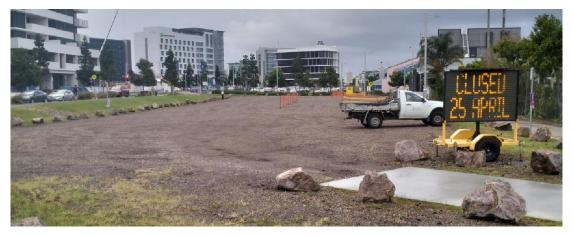
Photograph 2: General view of the site looking north from Sunshine Coast Parade

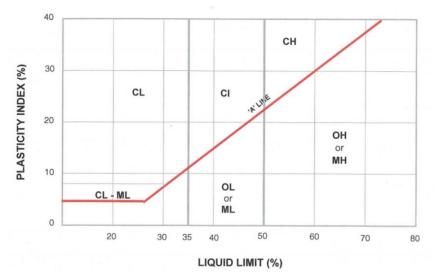
PLASTICITY CHART FOR CLASSIFICATION OF FINE GRAINED SOILS

(Reference: Australian Standard AS1726-1993 Geotechnical site investigations)

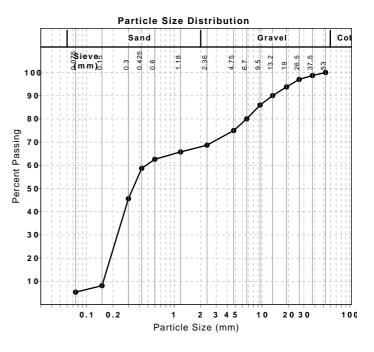
Sample Location: Bore 7 , Depth: 0.2 - 0.5m

Dry Density - Moisture Relationship (AS 1289 5.1.1 & 2.1.1)			Max
Mould Type	1 LITRE MOULD A		
Compaction	Standard		
Maximum Dry Density (t/m ³)	1.90		
Optimum Moisture Content (%)	9.5		
Oversize Sieve (mm)	19.0		
Oversize Material Wet (%)	6		
Method used to Determine Plasticity	Visual		
Curing Hours (h)	146.7		
Moisture Content (AS 1289 2.1.1)			
Moisture Content (%)		9	9.2

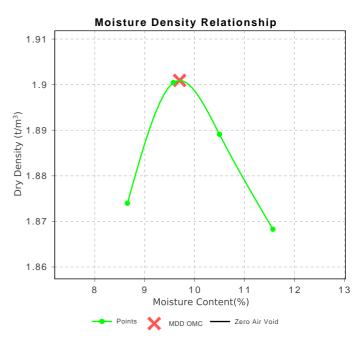
Sample Location: Bore 7 , Depth: 0.2 - 0.5m

California Bearing Ratio (AS 1289 6.1.1 & 2.1.1)			Max
CBR taken at	5 mm		
CBR %	45		
Method of Compactive Effort	Stan	dard	
Method used to Determine MDD	AS 1289 5.	.1.1 & 2	2.1.1
Method used to Determine Plasticity	Vis	ual	
Maximum Dry Density (t/m ³)	1.90		
Optimum Moisture Content (%)	9.5		
Laboratory Density Ratio (%)	100.0		
Laboratory Moisture Ratio (%)	99.0		
Dry Density after Soaking (t/m ³)	1.90		
Field Moisture Content (%)	9.2		
Moisture Content at Placement (%)	9.6		
Moisture Content Top 30mm (%)	11.9		
Moisture Content Rest of Sample (%)	11.8		
Mass Surcharge (kg)	4.5		
Soaking Period (days)	4		
Curing Hours (h)	26.0		
Swell (%)	0.0		
Oversize Material (mm)	19		
Oversize Material Included	Excluded		
Oversize Material (%)	5.8

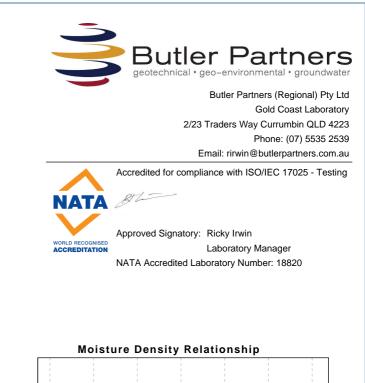
Dry Density - Moisture Relationship (AS 12 2.1.1)	Min	Max	
Mould Type	1 LITRE MOULD A		
Compaction	Standard		
Maximum Dry Density (t/m ³)	1.81		
Optimum Moisture Content (%)	11.0		
Oversize Sieve (mm)	19.0		
Oversize Material Wet (%)	1		
Method used to Determine Plasticity	Vis	sual	
Curing Hours (h)	146.8		
Moisture Content (AS 1289 2.1.1)			
Moisture Content (%)		;	8.9

Sample	Standard C	Standard Compaction	
Bore	Depth (m)	Sample Description	Moisture Content (%)	Maximum Dry Density (t/m³)	Optimum Moisture Content (%)	
7	0.2 - 0.5	Gravelly Sand	9.2	1.9	9.5	
8	0.2 – 1.0	Sand	8.9	1.8	11.0	
9	0.2 – 0.5	Fill – Sandy Gravel	13.9	2.0	9.0	
12	0.2 – 0.5	Fill – Sandy Gravel	8.7	2.0	9.5

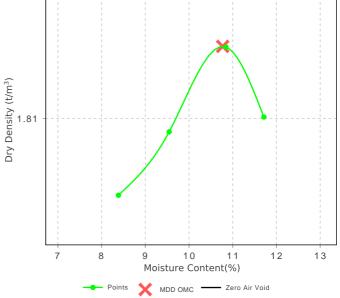
Sample Location: Bore 8 , Depth: 0.2 - 1.0m

California Bearing Ratio (AS 1289 6.1.1 & 2	.1.1)	Min	Max
CBR taken at	2.5 mm		
CBR %	30		
Method of Compactive Effort	Standard		
Method used to Determine MDD	AS 1289 5	.1.1 & 2	2.1.1
Method used to Determine Plasticity	Vis	ual	
Maximum Dry Density (t/m ³)	1.81		
Optimum Moisture Content (%)	11.0		
Laboratory Density Ratio (%)	99.5		
Laboratory Moisture Ratio (%)	102.5		
Dry Density after Soaking (t/m ³)	1.81		
Field Moisture Content (%)	8.9		
Moisture Content at Placement (%)	11.1		
Moisture Content Top 30mm (%)	13.4		
Moisture Content Rest of Sample (%)	13.1		
Mass Surcharge (kg)	4.5		
Soaking Period (days)	4		
Curing Hours (h)	26.2		
Swell (%)	0.0		
Oversize Material (mm)	19		
Oversize Material Included	Excluded		
Oversize Material (%)	1.0

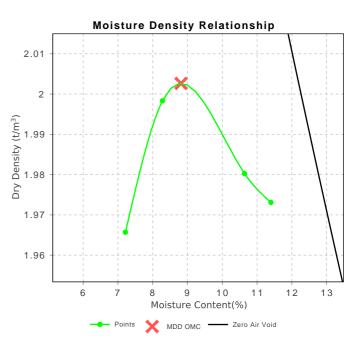
Sample Location: Bore 9 , Depth: 0.2 - 0.5m

California Bearing Ratio (AS 1289 6.1.1 & 2	.1.1)	Min	Max
CBR taken at	5 mm		
CBR %	70		
Method of Compactive Effort	Star	ndard	
Method used to Determine MDD	AS 1289 5	.1.1 & 2	2.1.1
Method used to Determine Plasticity	Vis	sual	
Maximum Dry Density (t/m ³)	2.00		
Optimum Moisture Content (%)	9.0		
Laboratory Density Ratio (%)	100.0		
Laboratory Moisture Ratio (%)	102.0		
Dry Density after Soaking (t/m ³)	2.00		
Field Moisture Content (%)	13.9		
Moisture Content at Placement (%)	9.0		
Moisture Content Top 30mm (%)	9.7		
Moisture Content Rest of Sample (%)	9.4		
Mass Surcharge (kg)	4.5		
Soaking Period (days)	4		
Curing Hours (h)	26.4		
Swell (%)	-0.5		
Oversize Material (mm)	19		
Oversize Material Included	Excluded		
Oversize Material (%)	9.9
