GEOTECHNICAL REPORT: Proposed MIBA South

Precinct 5B, 5C, 5D, 13A and 7C

Yarrabilba

PG-5335-G

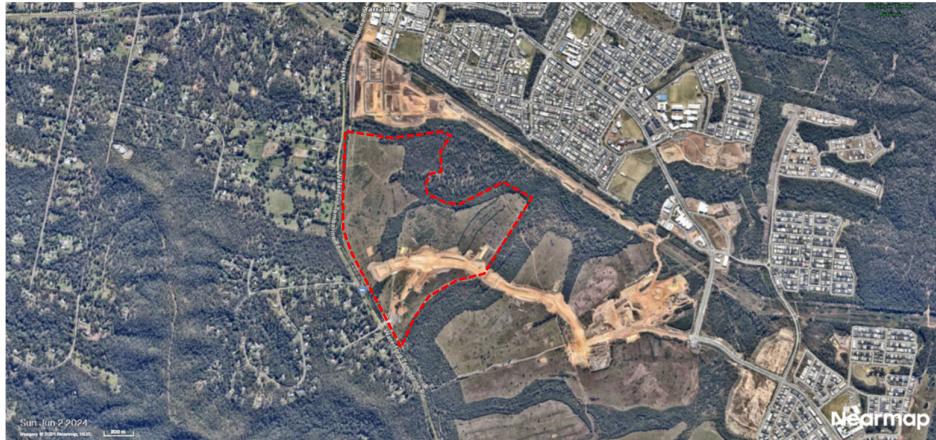
## AERIAL IMAGE

Site drainage in the majority of the site was considered fair, however in the creek areas around the centre of the site, drainage was considered poor and expected to be unpassable during and following periods of wet weather. Refer following aerial and site photographs for typical site conditions.
