BROADSCALE GEOTECHNICAL INVESTIGATION

PROPOSED RESIDENTIAL COMMUNITY DEVELOPMENT

WYATT ROAD

UNDULLAH

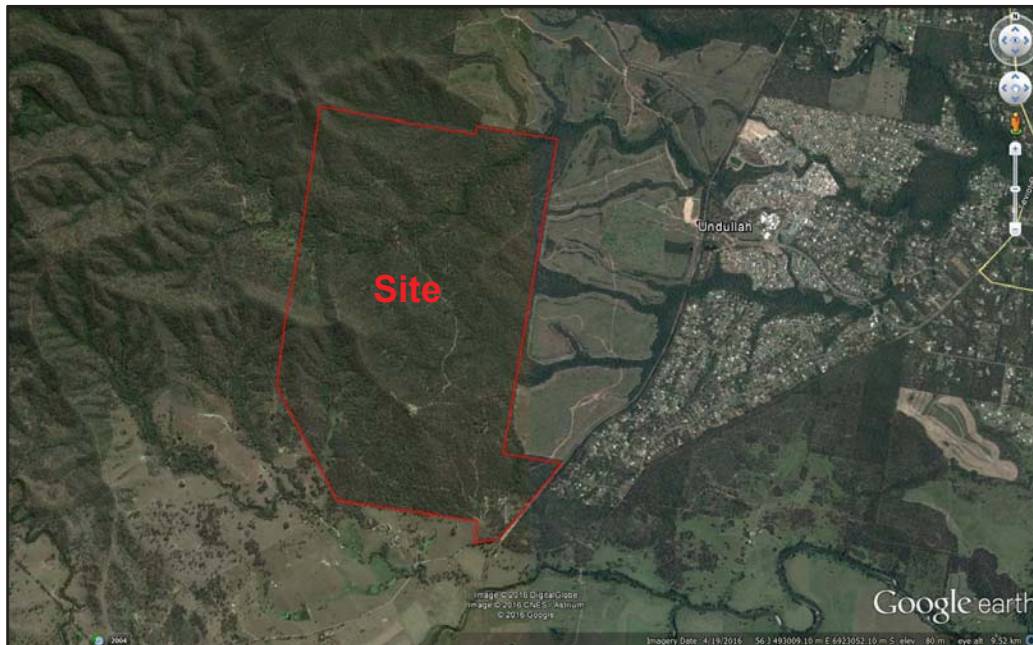
FIGURE 2 – AERIAL IMAGE

The site of the proposed residential community development is located at Wyatt Road, Undullah, is described as Lot 3 on RP 45236, Lot 28 on SP S311174 and Lot 3 on RP 49296, and comprises approximately 1024.8 hectares of land. Refer Figure 2 for site location.

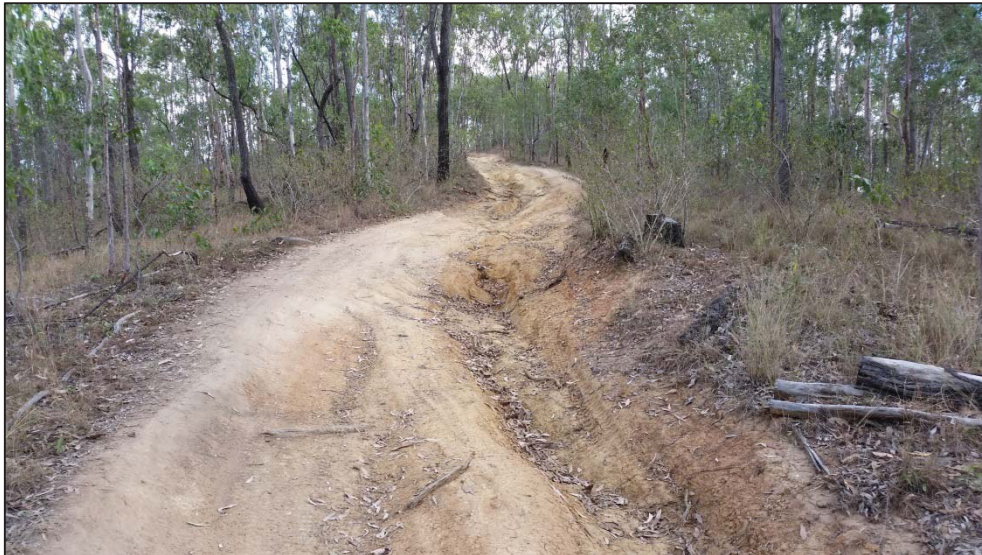
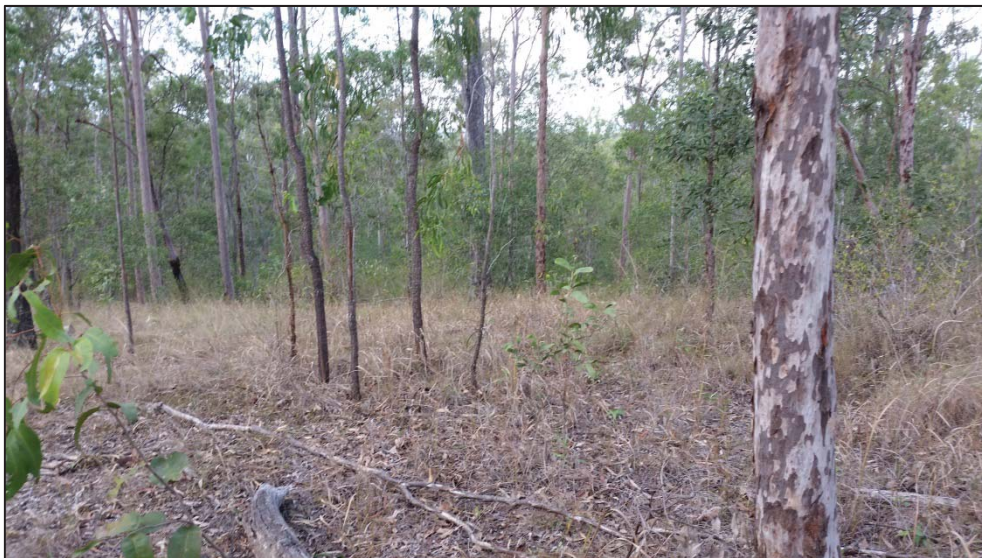
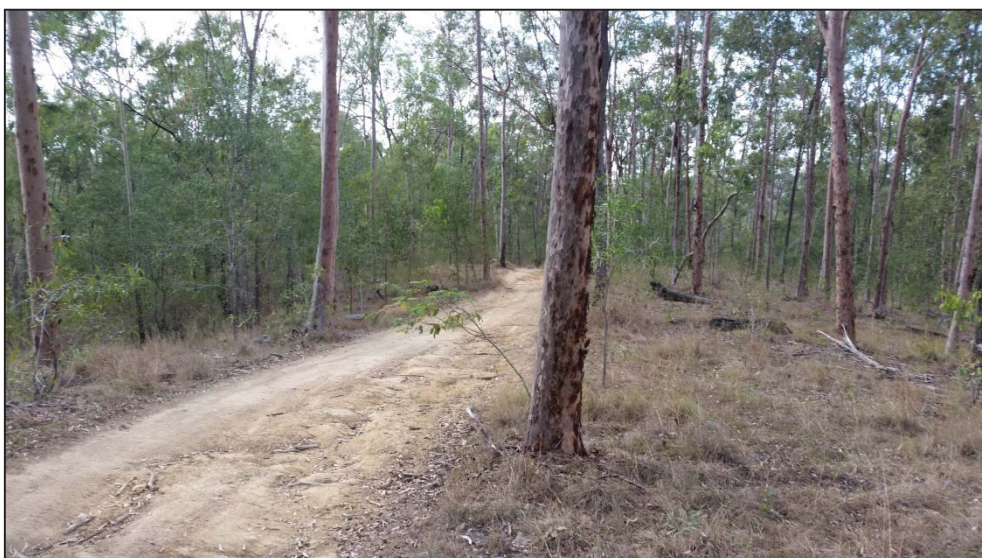
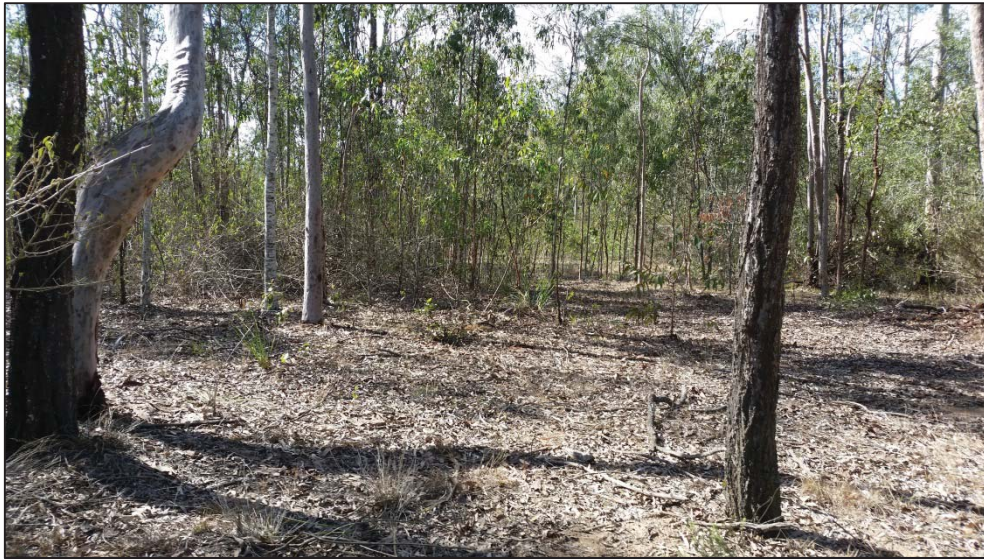
Significant erosion gullies were noted across the site, where clearing of the vegetation had been undertaken. This was especially noted on the downhill slopes of the access tracks.

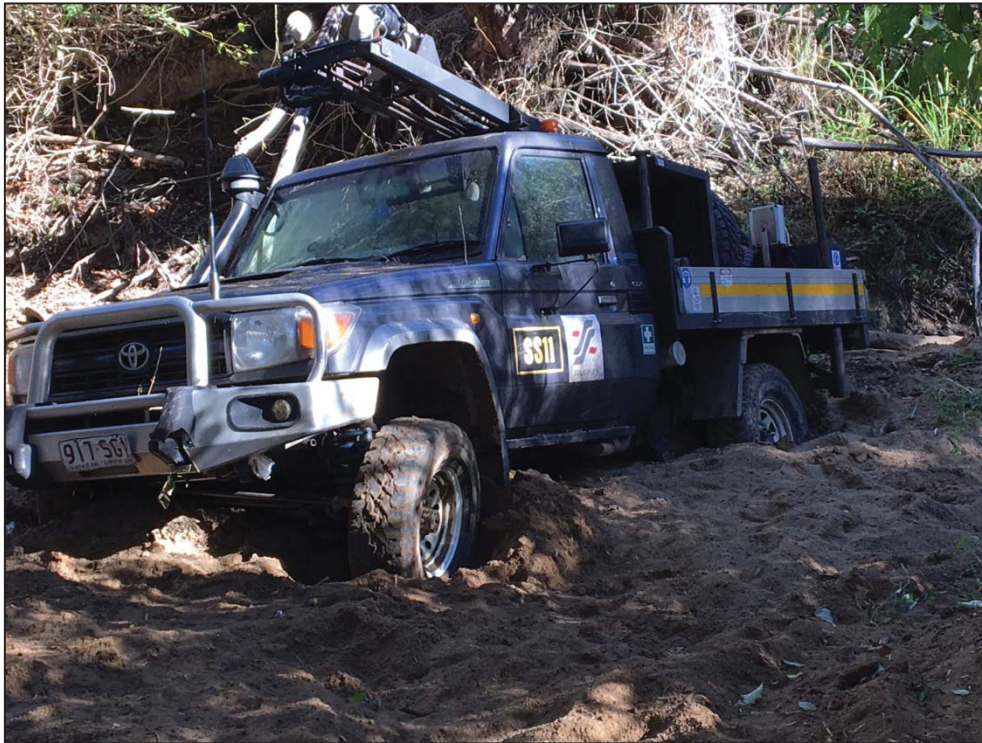
At the time of the field investigation, trafficability was considered to be fair across the majority of the site, where access was available around the existing vegetation, due to the dry weather conditions encountered. However, trafficability through the lower lying areas of the site was significantly restricted with vehicles becoming bogged in the creek crossing.

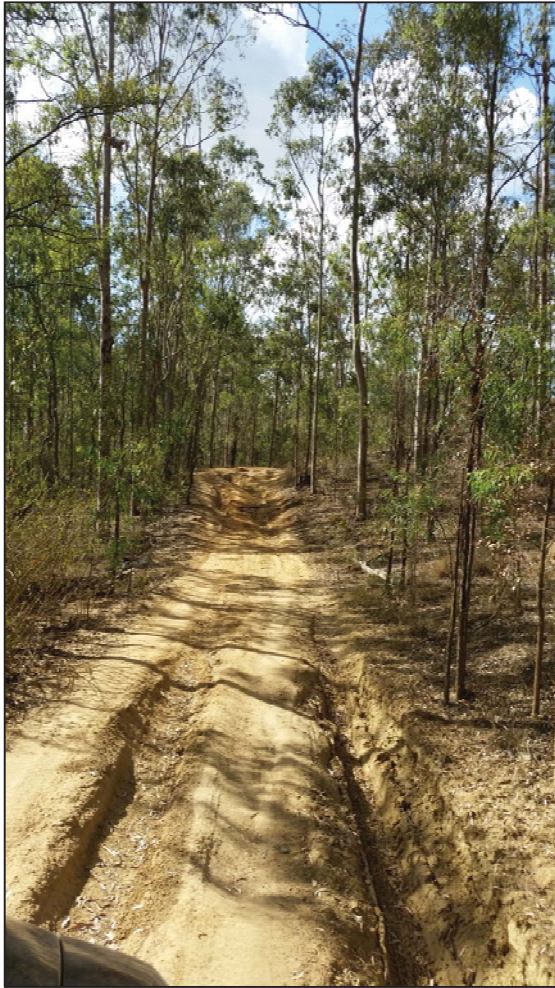
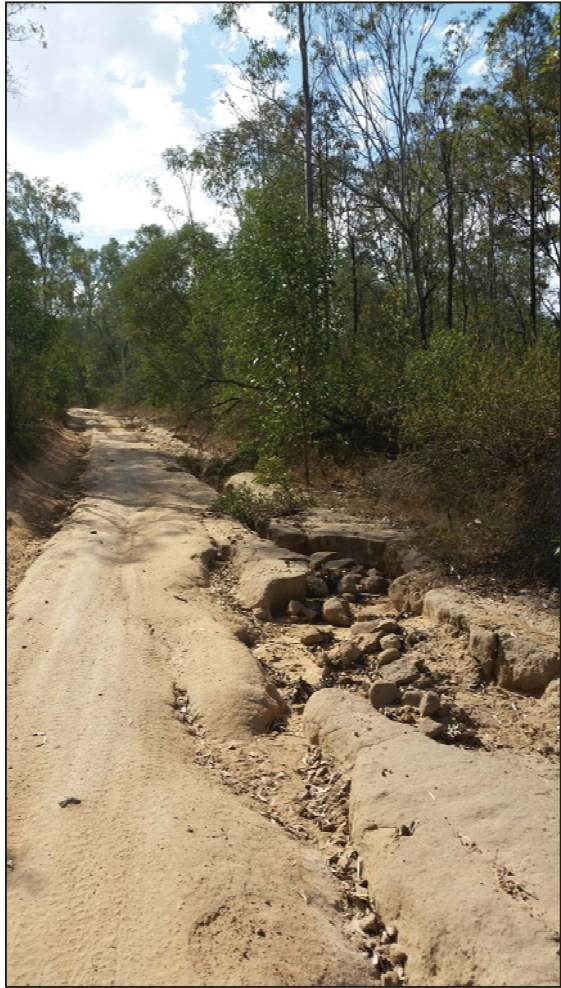
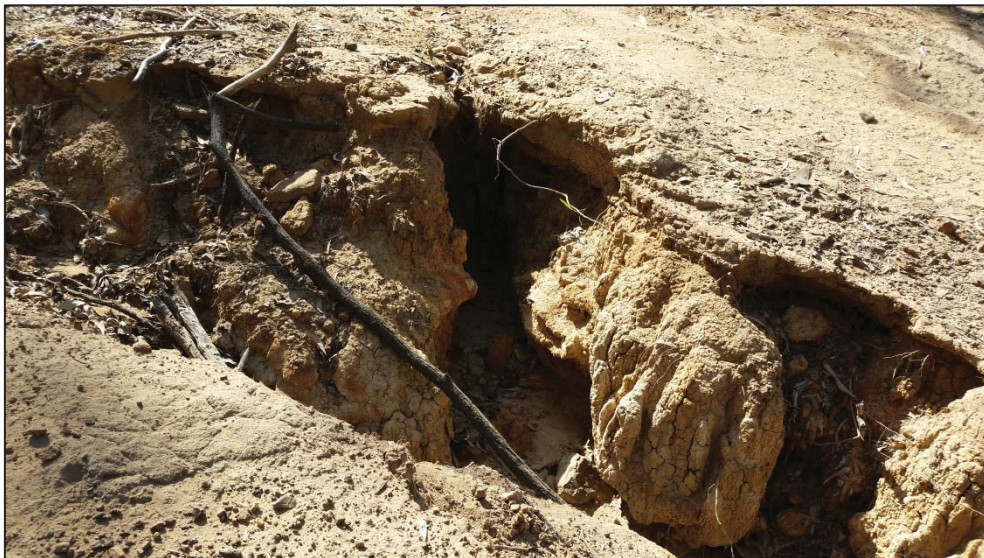
Soils with relatively high silt and fine sand fractions are most susceptible to erosion, while very fine grained, high plasticity clay soils are least susceptible. The majority of the surficial materials were silts and sands and are therefore considered susceptible to erosion.

- Sheet erosion which is removing the shallow surface soils initiated by rainfall splash and then runoff and is seen as the accumulation of sediment and soil debris at the base of the slope features.
- Rill erosion evident as small channels typically less than 300mm deep in the access track, and adjacent to the main drainage features and the tributary gullies, caused by concentrations of rainfall runoff.
- Gully erosion where continued concentrated surface runoff has caused deepening of the erosion rills, to form large gullies up to 2m deep, across the site.

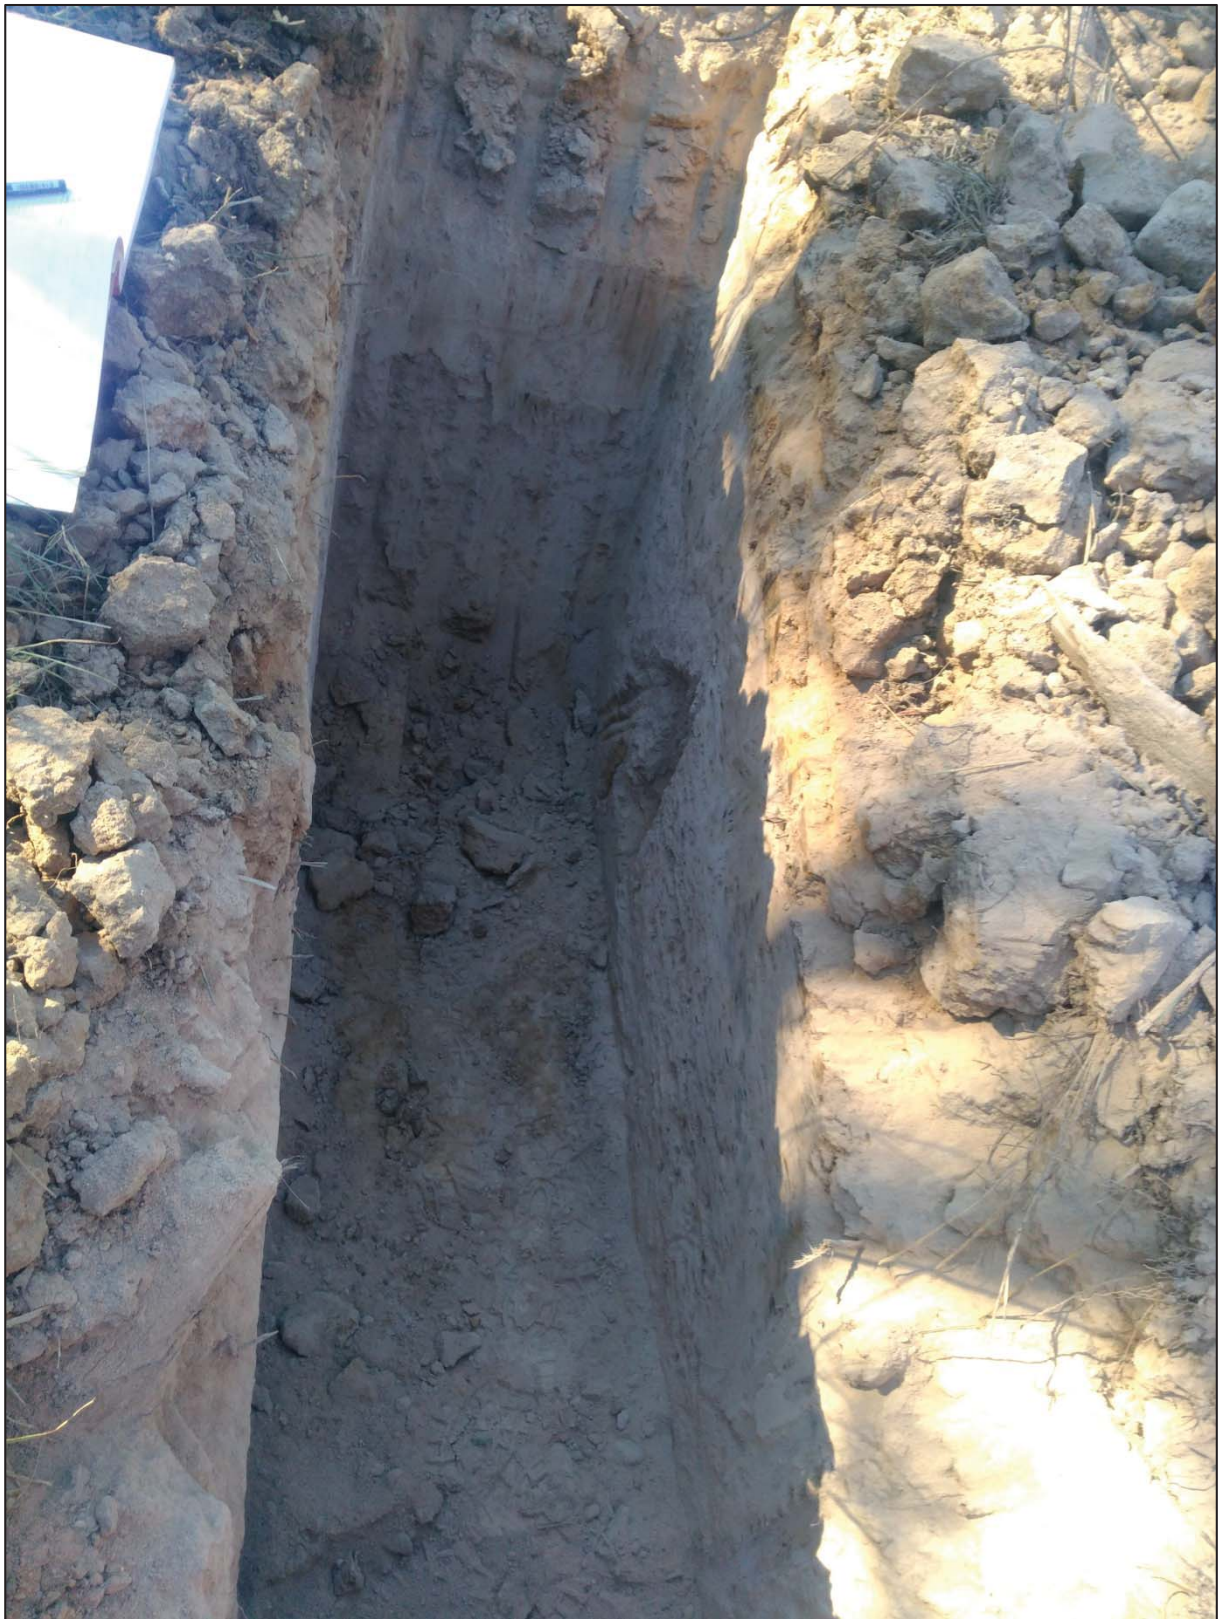
Test Pit 1

Drilling Method					Depth	Graphic	Description	DCP Test (blows/100mm)						Samples and Remarks
TC	WB	RR	NWLC	Casing				0	6	12	18	24	30	
					0.20		NATURAL Sandy CLAY (CL-CI) Hard, low to medium plasticity. mottled light brown and light grey, fine to medium grained sand, traces of root fibres and organics, moist.							[d]
					0.5		Clayey SAND (SC) Dense, fine to medium grained, light brown, low plasticity fines, with silt, moist. (Tending to Sandstone)							[d]
					0.70		SANDSTONE (XW) Extremely weathered, extremely weak, mottled light brown and light grey, moist.							
					0.90		SANDSTONE (DW) Distinctly weathered, medium strong, mottled light brown and light grey, moist.							
					1.00		TEST PIT TP 01 TERMINATED AT 1.00 m							
					1.5									
					2.0									
					2.5									
					3.0									
					3.5									
					4.0									
					4.5									
					5.0

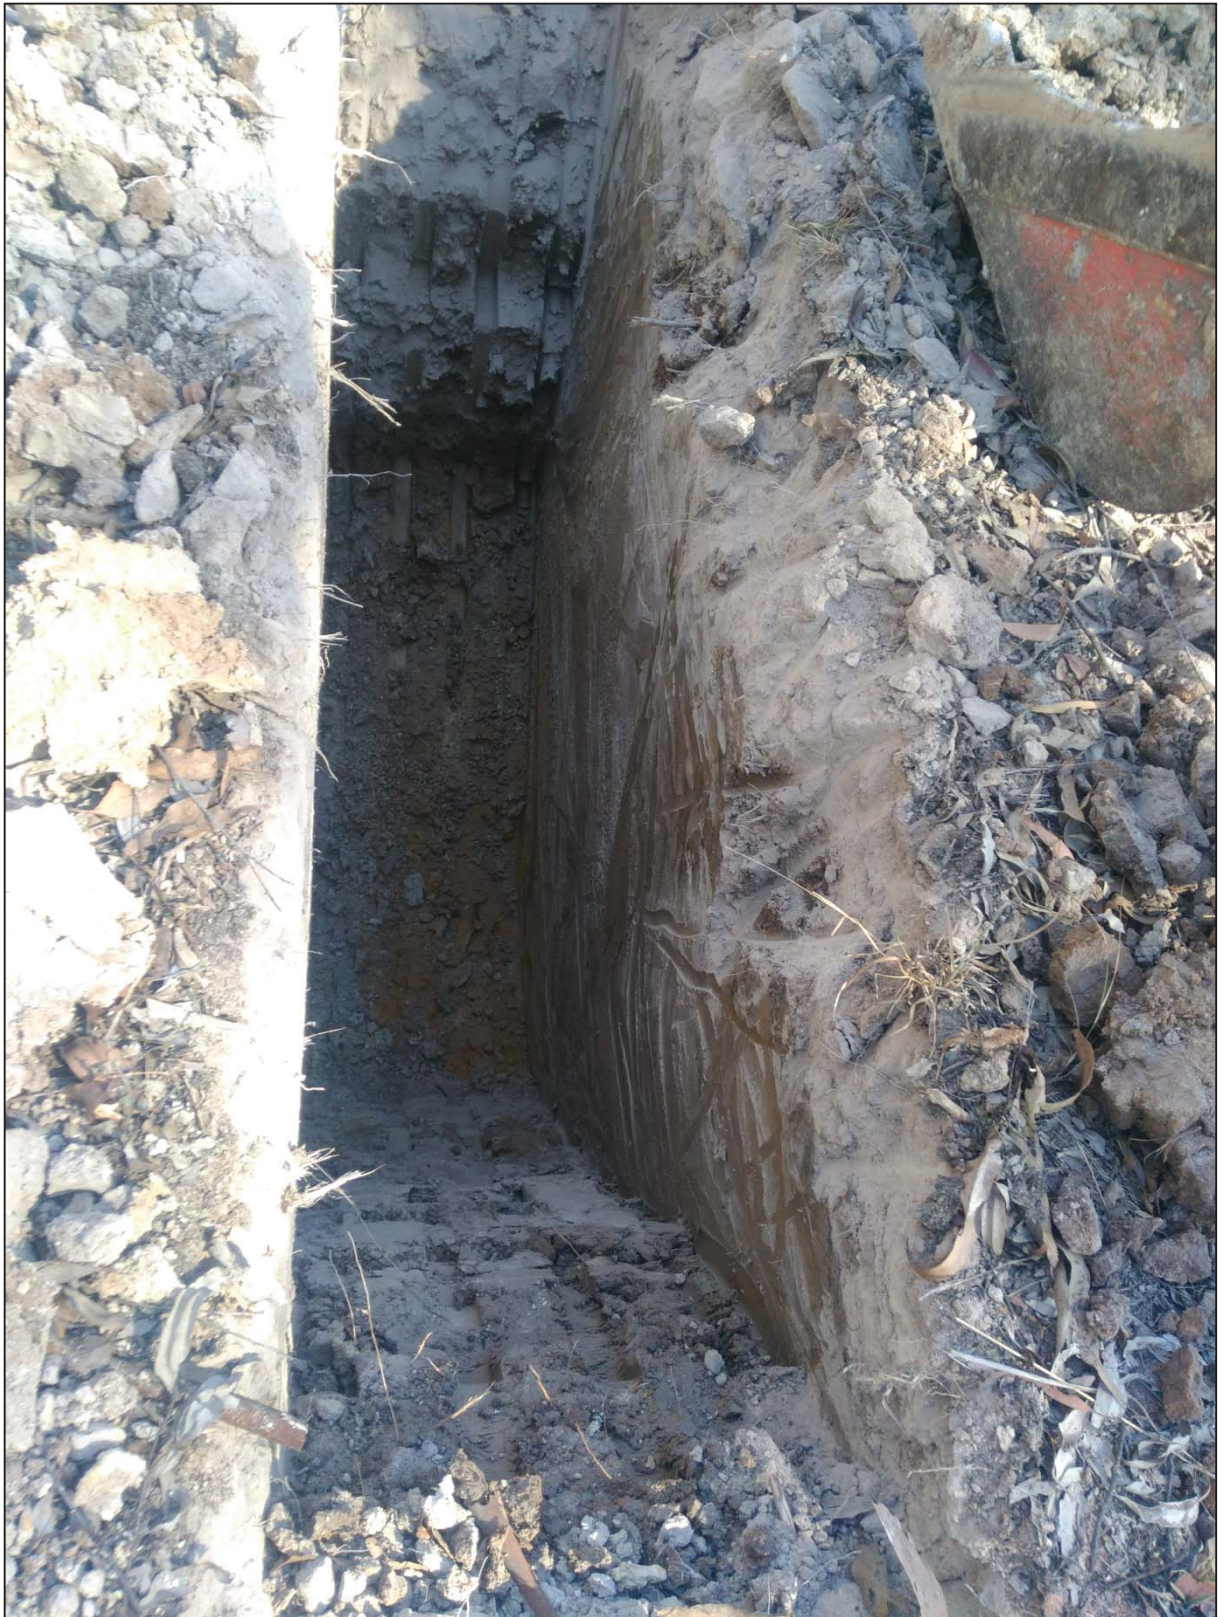
Test Pit 2

Drilling Method					Depth	Graphic	Description	DCP Test (blows/100mm)						Samples and Remarks
TC	WB	RR	NWLC	Casing				0	6	12	18	24	30	
					0.15		NATURAL Silty SAND (SM) Medium dense, fine to medium grained, light brown, trace of root fibres, moist.

0.5		Silty CLAY (CH) Hard, high plasticity, mottled orange brown, trace of sand, moist.							[D]
					1.0		Silty CLAY (CH) Hard, high plasticity, brown, trace of sand, moist.

1.40		Silty CLAY (CH) Very stiff to hard, high plasticity, mottled light grey and light brown, trace of sand, moist.							[D]
					1.5		SANDSTONE (XW) Extremely weathered, extremely weak, light brown, moist.

1.70		SANDSTONE (DW) Distinctly weathered, medium strong, light brown, moist.							[D]
					1.90									
					2.0		TEST PIT TP 02 TERMINATED AT 1.90 m

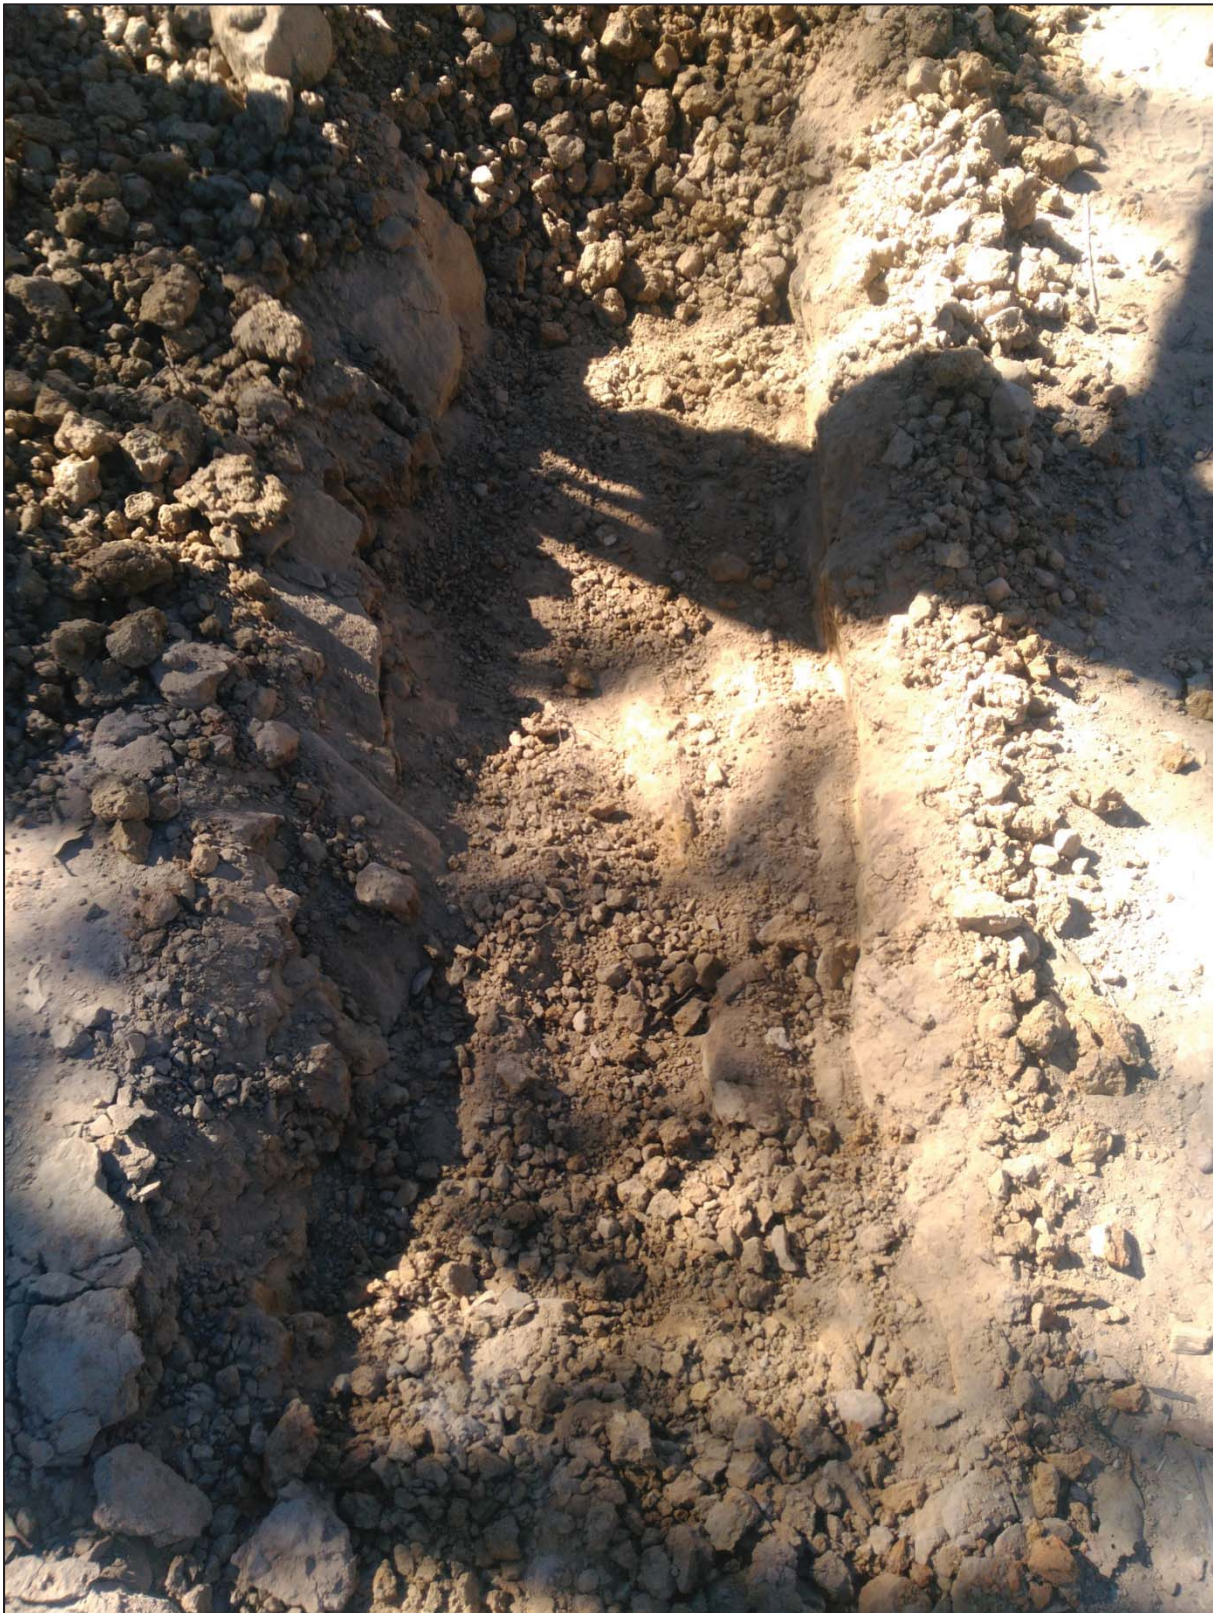
Test Pit 3

Drilling Method					Depth	Graphic	Description	DCP Test (blows/100mm)						Samples and Remarks
TC	WB	RR	NMLC	Casing				0	6	12	18	24	30	
					0.15		NATURAL Sandy CLAY (CI) Hard, medium plasticity, mottled orange brown, fine to medium grained sand, moist.							b
					0.25		SANDSTONE (DW) Distinctly weathered, medium strong, light brown, moist.							
					0.5		TEST PIT TP 03 TERMINATED AT 0.25 m							
					1.0									
					1.5									
					2.0									
					2.5									
					3.0									
					3.5									
					4.0									
					4.5									
					5.0
