GEOTECHNICAL INVESTIGATION

PROJECT NO. 1-12516

APARTMENT BUILDINGS

825 STANLEY STREET, WOOLLOONGABBA

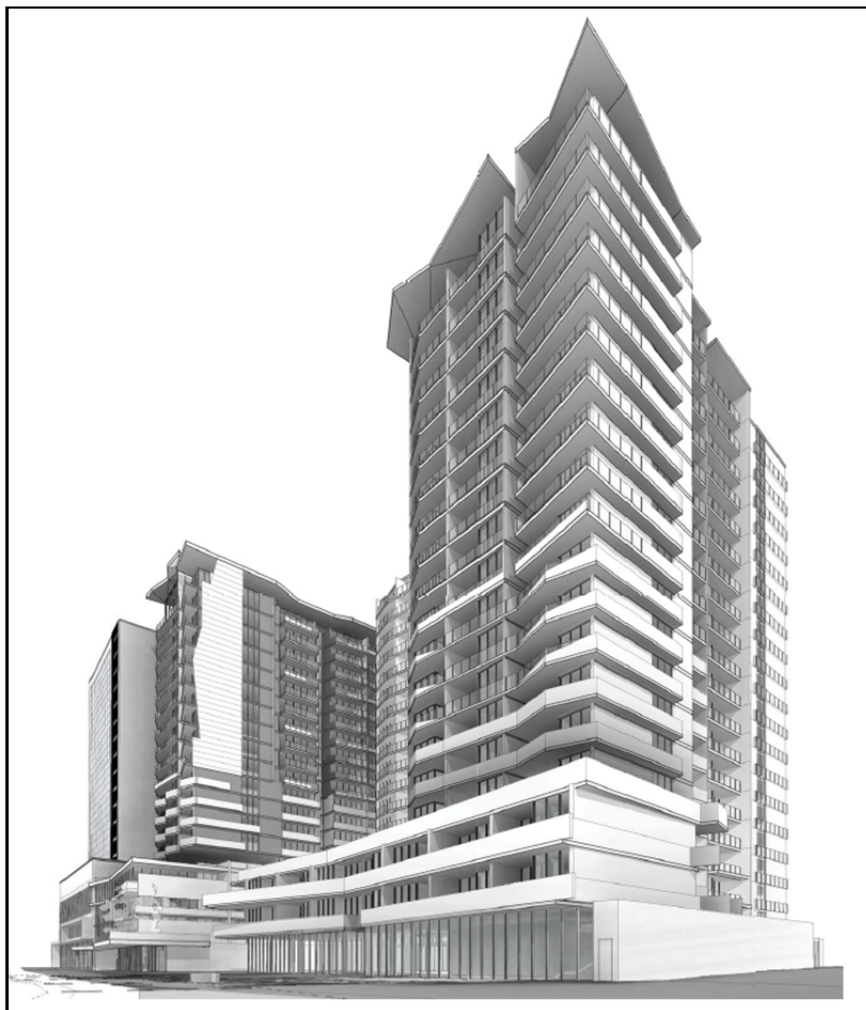
FIGURE 1 – STANLEY STREET PERSPECTIVE

- Three, twenty level towers, constructed in three stages.
- Buildings 2 and 3 will incorporate three levels of basement carparking. Earthworks will comprise excavations of up to 9.5m to form the lower basement level of RL - 4.5m.
- No basement is proposed for Building 1. However, excavation to RL 3.0m is proposed at Building 1 location to create a lined detention basin (concrete base and walls) beneath ground floor; the detention basin will be located to the east of the brick drain.

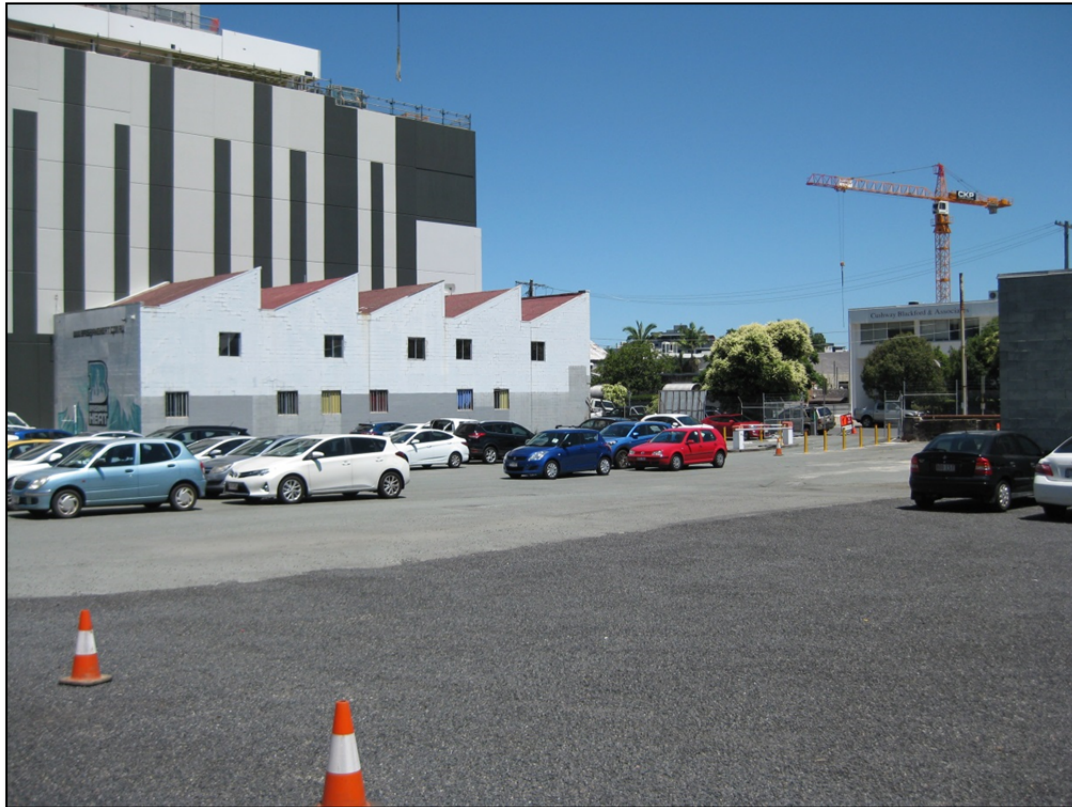
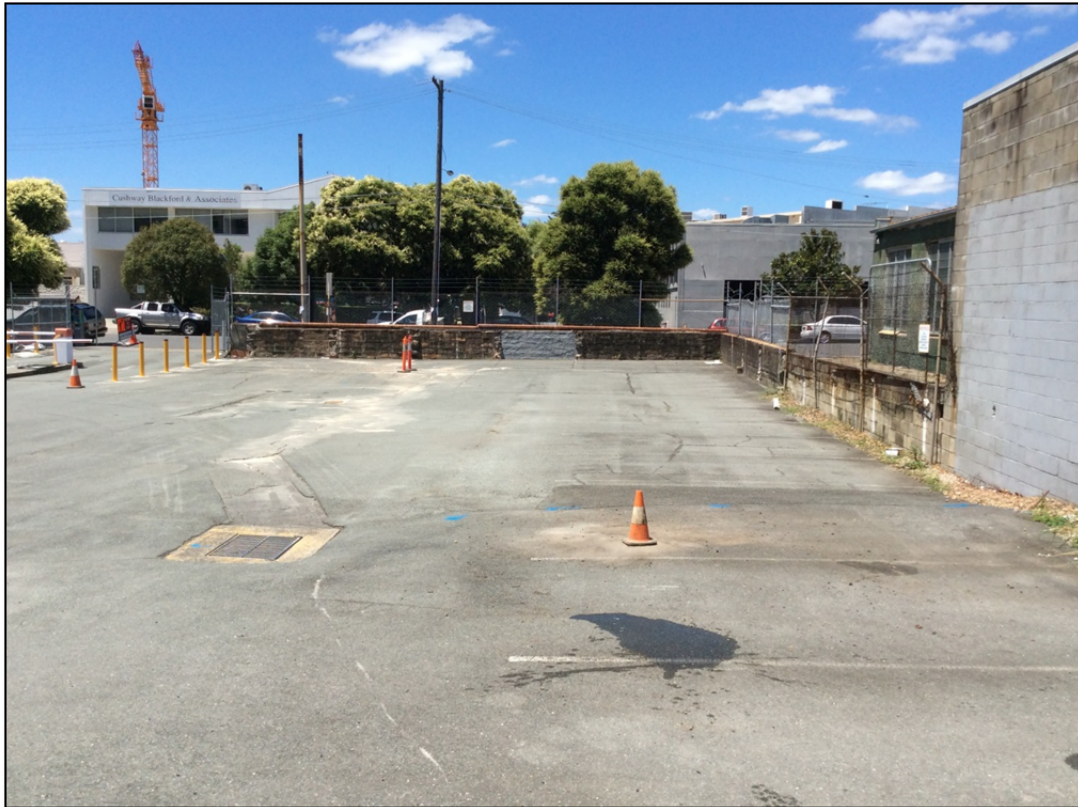
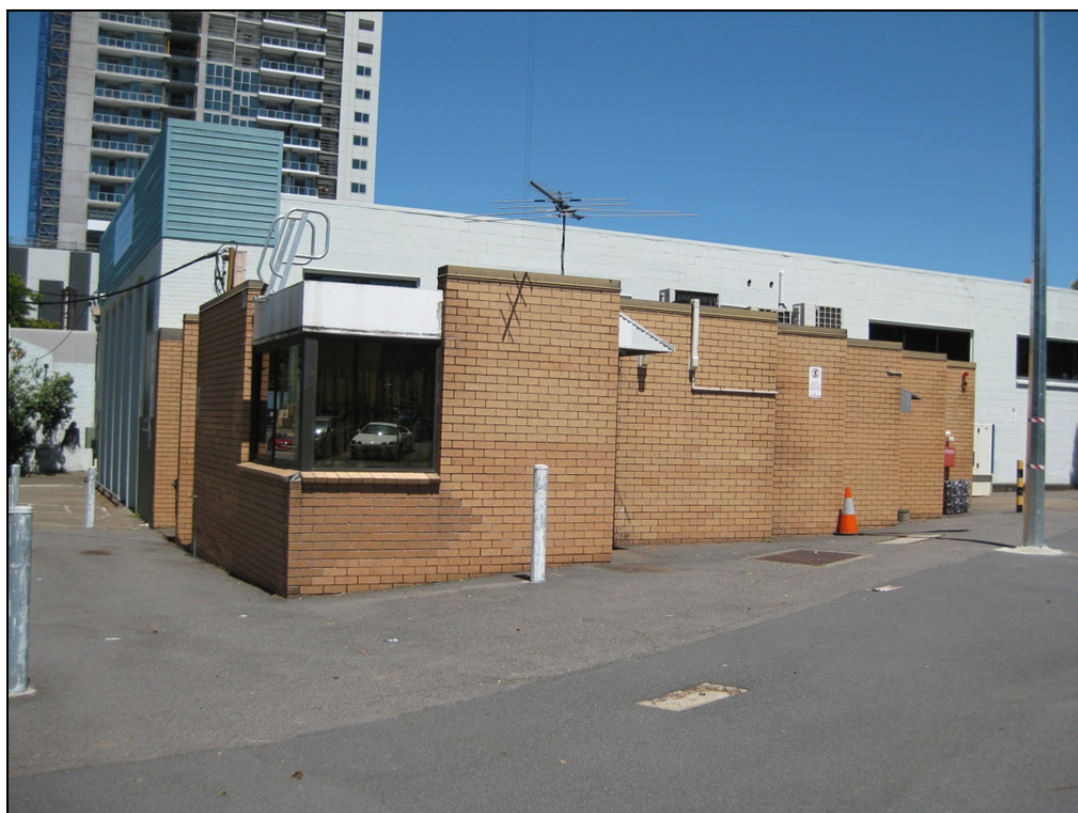
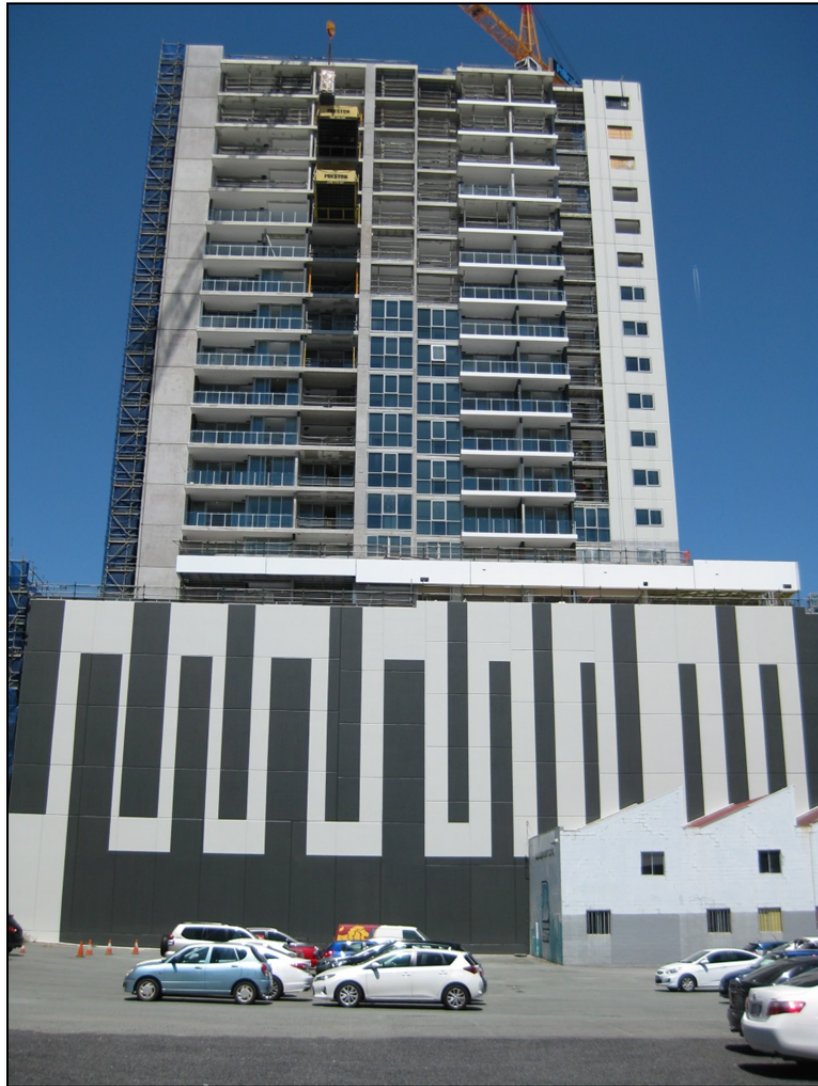
The site is occupied by a series of single and two level structures, along with a large open carpark area.

- Southern Boundary – Trafalgar Street.
- Western Boundary – Jurgen Street, with a single storey brick veneer “BCC Building” (refer Photograph 3) located adjacent the north western corner of the development site.

Photographs 1 to 4 indicate typical site conditions. Please also refer Detailed Survey prepared by Jensen Bowers (Appendix D).

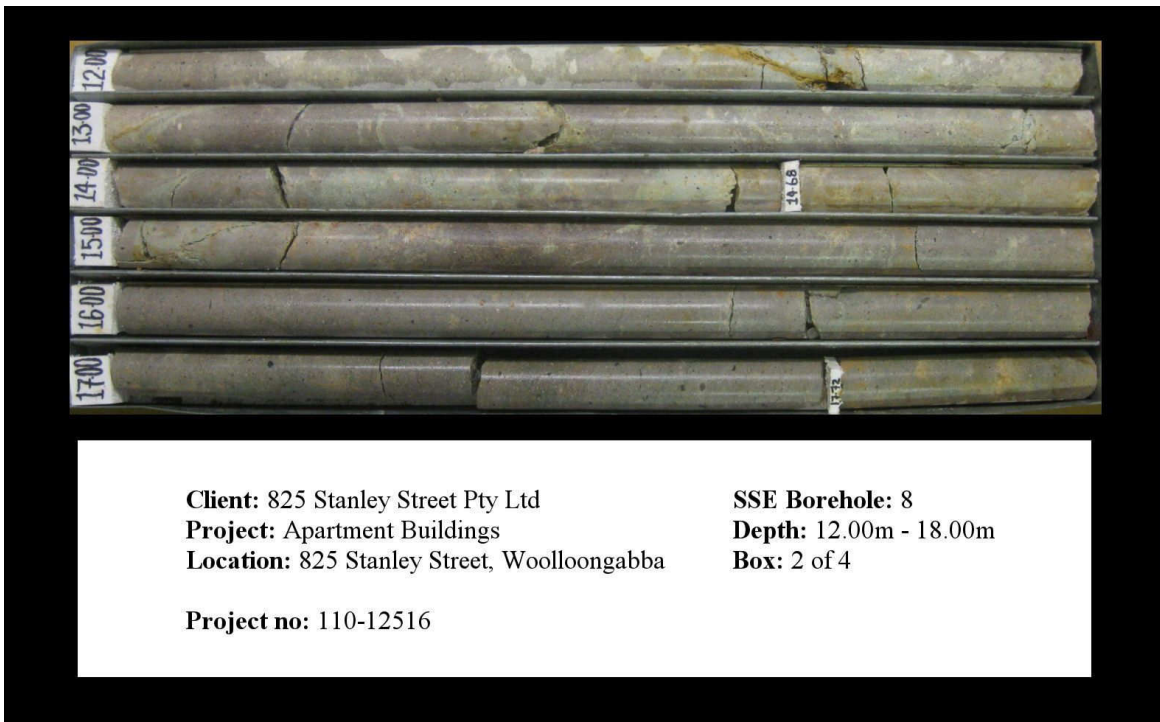
TITLE
 825 Stanley Pty Ltd
 825 Stanley Street, Woolloongabba
 Apartment Buildings
 Core Photo - BH 08

SSE Borehole: 8
Depth: 6.10m - 12.00m
Box: 1 of 4

SSE Borehole: 8
Depth: 12.00m - 18.00m
Box: 2 of 4

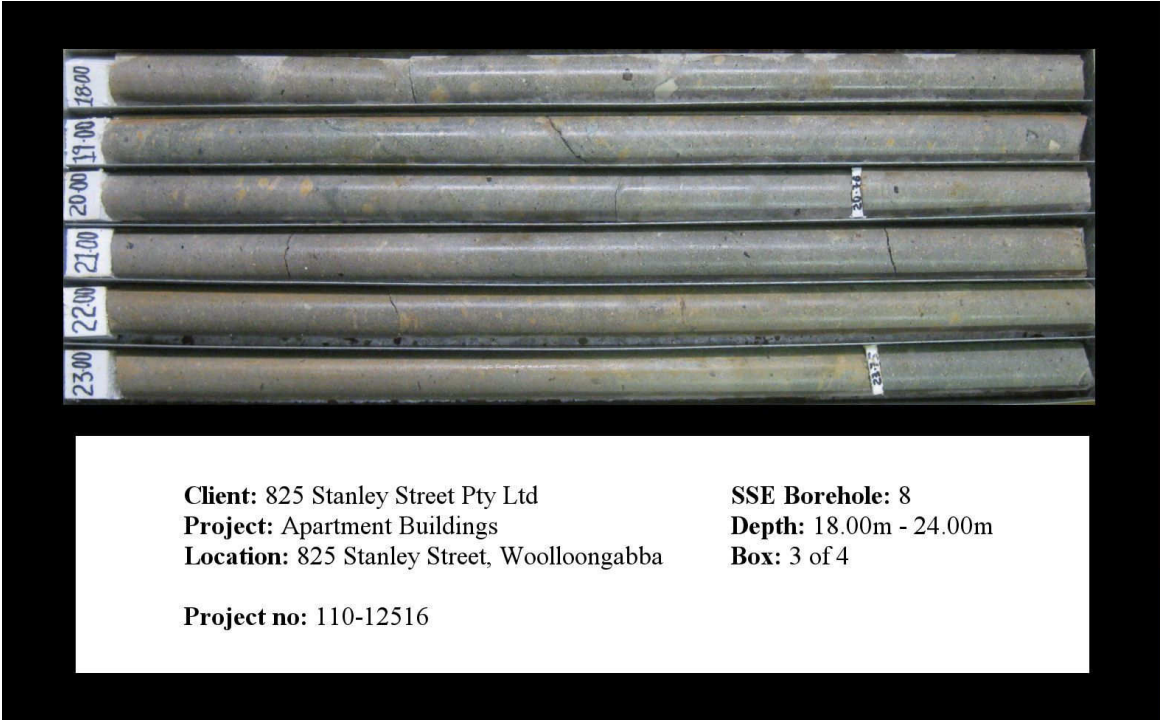
TITLE 825 Stanley Pty Ltd 825 Stanley Street, Woolloongabba Apartment Buildings Core Photo - BH 08	DRAWN CB	DATE 18/01/2016	
		CHECKED GB	DATE 18/01/2016	
		SCALE Not To Scale		A4
		PROJECT No 110-12516	FIGURE No 2/2

PointID : BH 08 Depth Range: 24.00 - 26.77 m

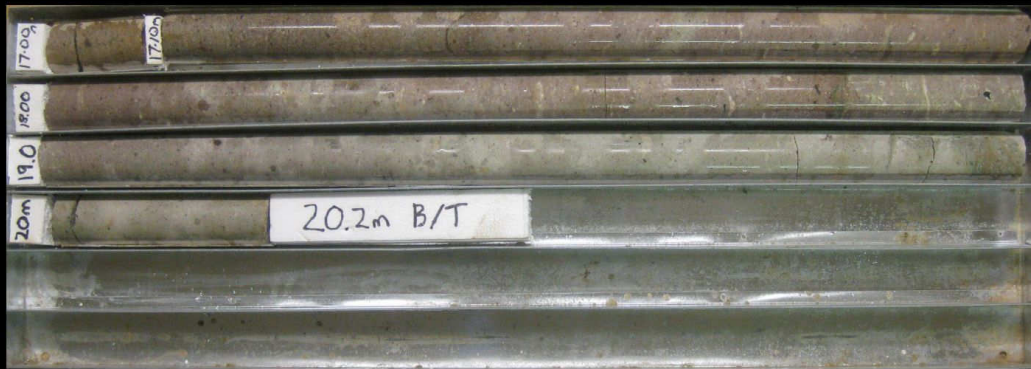
TITLE 825 Stanley Pty Ltd 825 Stanley Street, Woolloongabba Apartment Buildings Core Photo - BH 09	DRAWN CB	DATE 18/01/2016	
		CHECKED GB	DATE 18/01/2016	
		SCALE Not To Scale		A4
		PROJECT No 110-12516	FIGURE No 1/2

PointID : BH 09 Depth Range: 11.00 - 17.00 m

SSE Borehole: 9
Depth: 17.00m - 20.20m
Box: 3 of 3

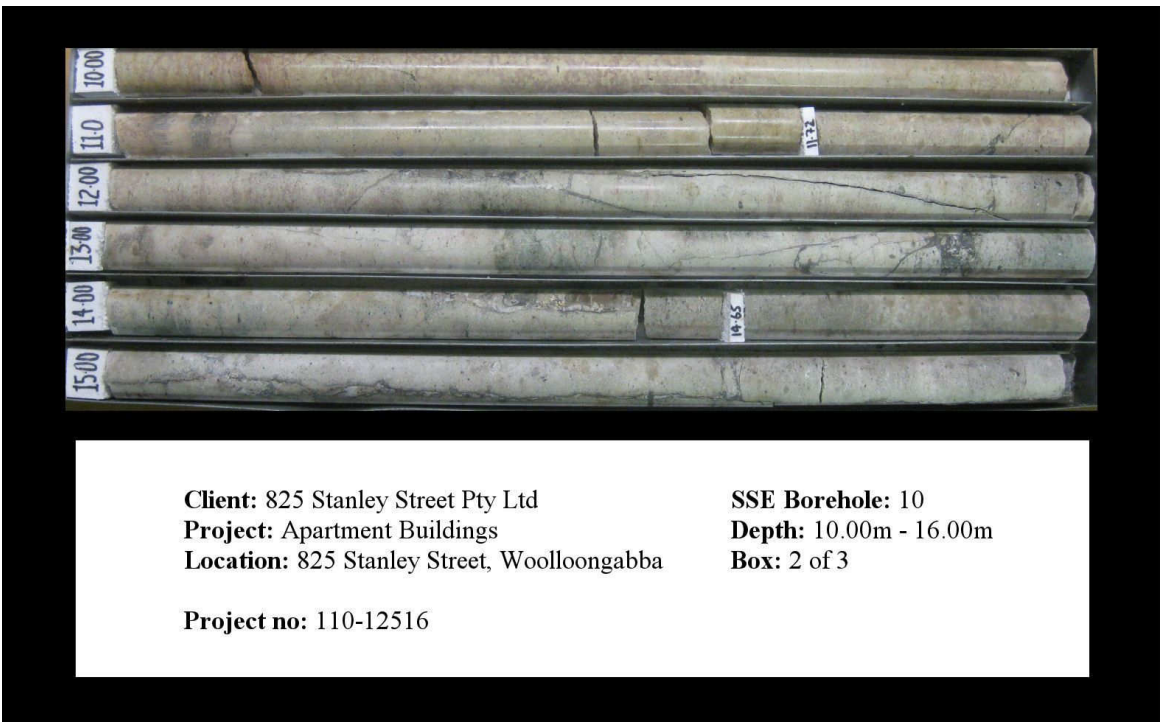
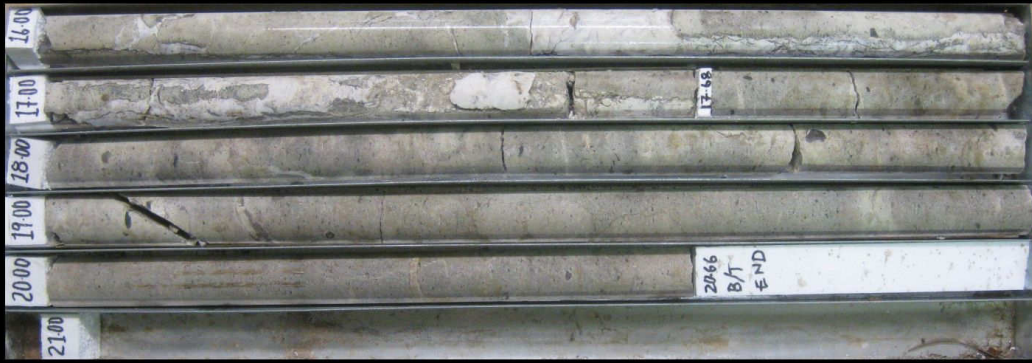
TITLE
 825 Stanley Pty Ltd
 825 Stanley Street, Woolloongabba
 Apartment Buildings
 Core Photo - BH 10

SSE Borehole: 10
Depth: 4.60m - 10.00m
Box: 1 of 3

SSE Borehole: 10
Depth: 10.00m - 16.00m
Box: 2 of 3

SSE Borehole: 10
Depth: 16.00m - 20.66m
Box: 3 of 3
