Independent Arboricultural Services

Arboricultural Impact Assessment

11-23 Macarthur Avenue
Hamilton QLD 4007

IAS11653

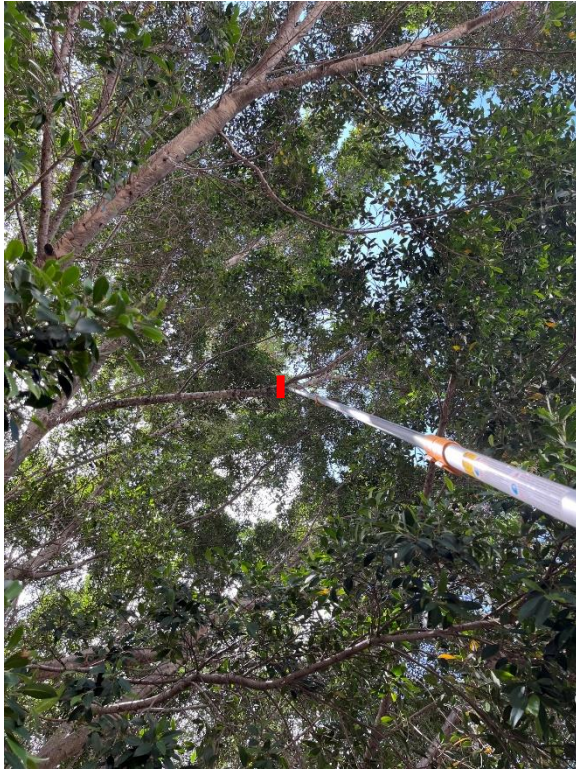
Tree 1 – 100mm branch to be pruned

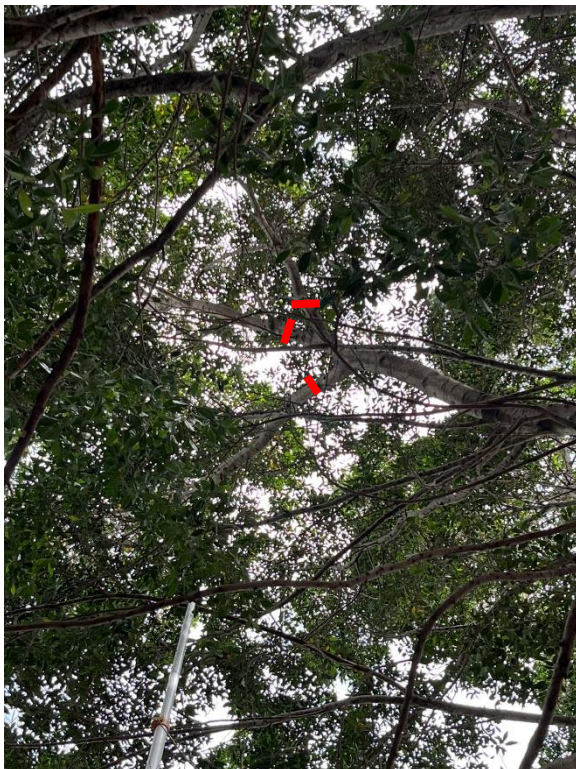
Tree 1 - 3 x 100 branches to be pruned

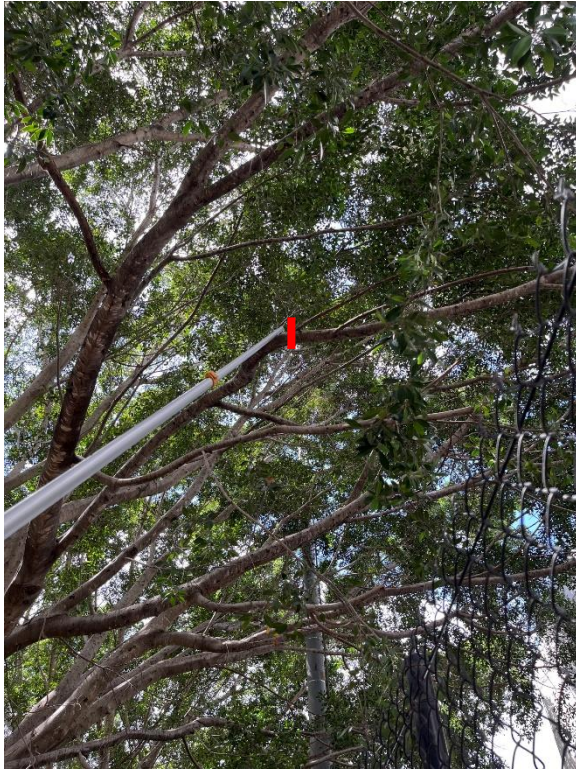
Tree 2 - 80mm branch to be pruned

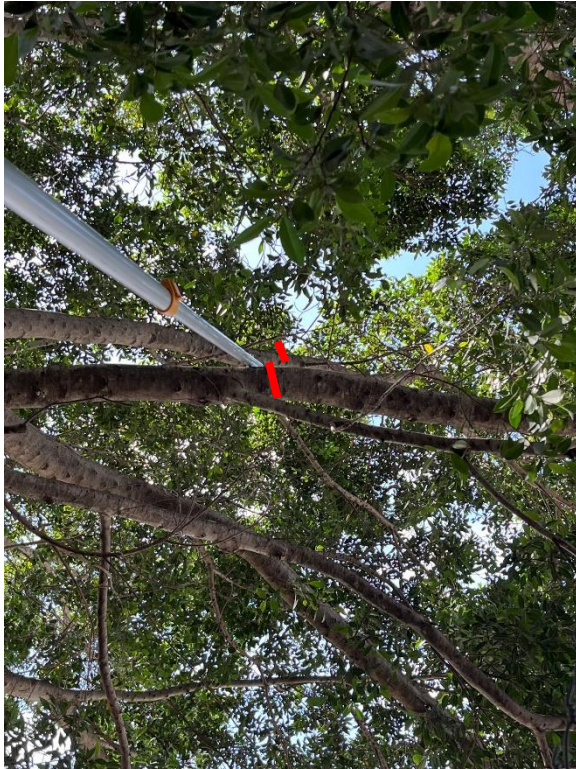
Tree 3 – 100mm and 80 mm branches to be pruned

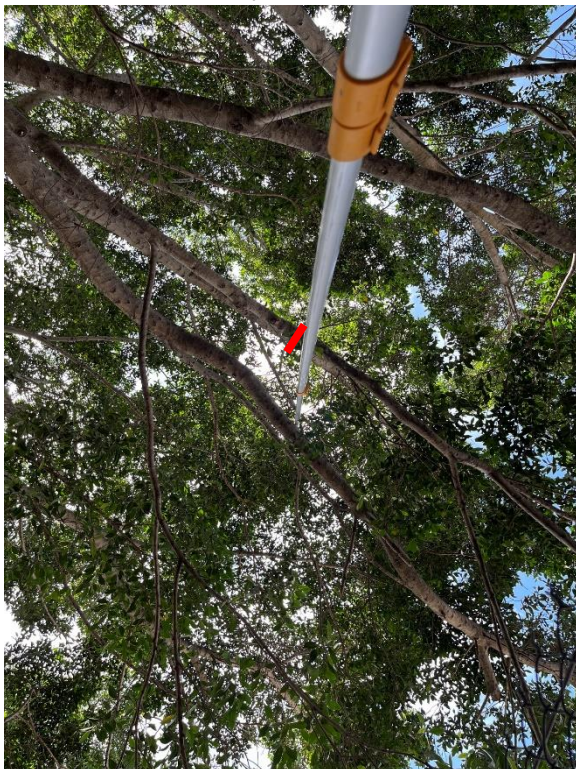
Tree 3 - 100mm branch to be pruned

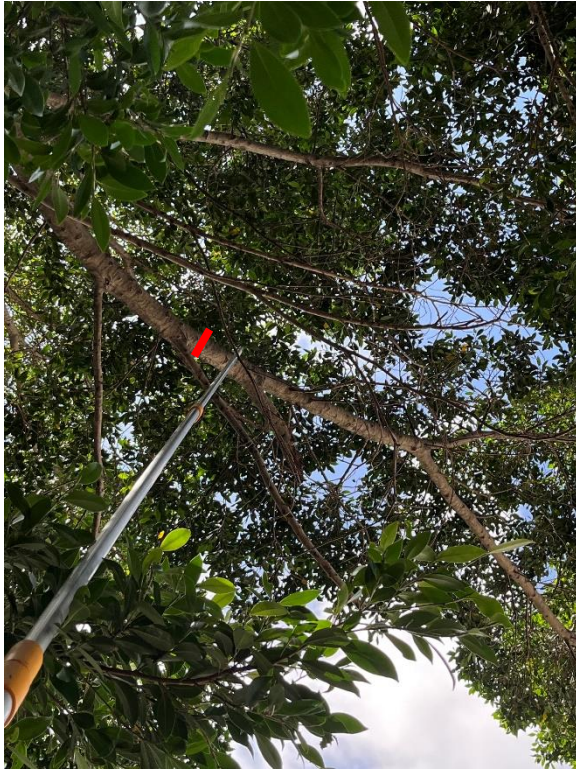
Tree 3 - 100 mm branch to be pruned

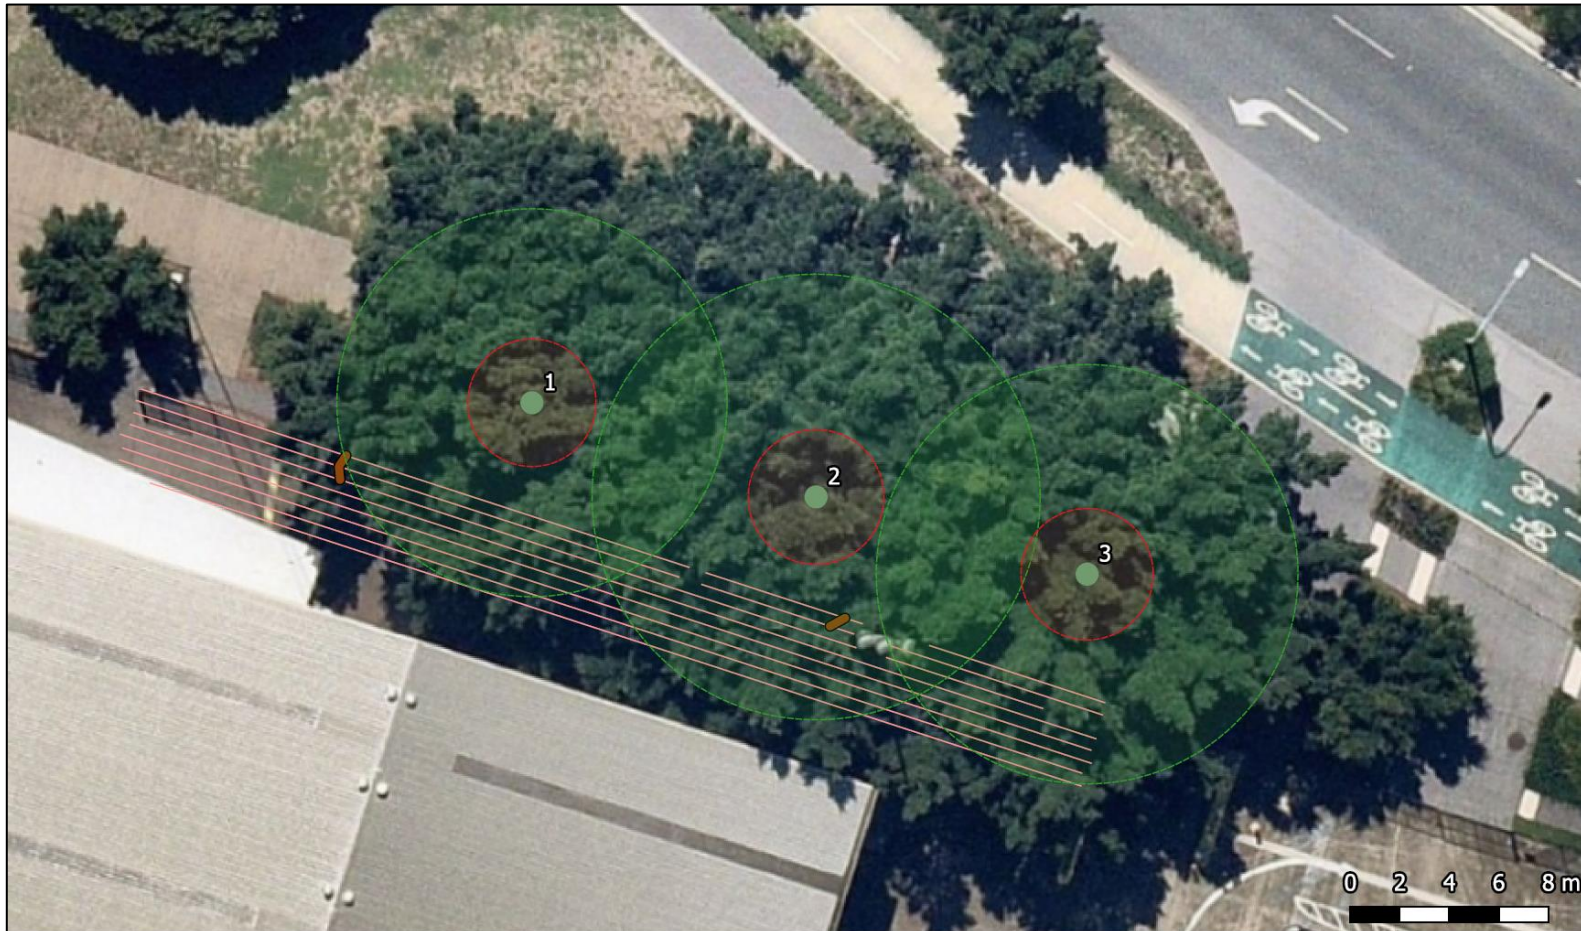
Ground Penetrating Radar

Ground penetrating radar was utilised between the property boundary and the existing building structure to determine of any root activity was observable within the property boundary. Work was undertaken on the 13th July 2023. In summary, it is the authors opinion that limited root activity was observed within the *Subject area*. Numerous services were observed within the property. Externally it was also observed that power and communications are running close to the property boundary. Please see page 23 for results.
